Manhole Inspection Summary

Manhole # S37II1008MH

Insp Date: **1/15/07 1:18 PM**

Location Address: **4225 GREENMOUNT AVE**

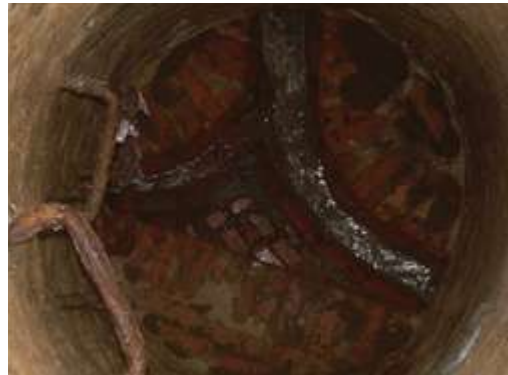
Top View

Corroded steps. Evidence of surcharge - Bench derbsi.

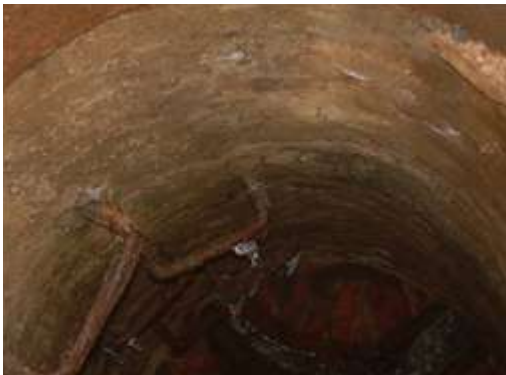
Defect

☒ **Leaks**

Condition: ☐ Sound ☐ Cracked ☐ Root Intrusion ☐ Loose Brick ☒ **Deteriorated**

Infiltration: ☐ None ☒ **Joint** ☐ Cracks ☐ Mortar ☐ Roots ☒ **Wall**

Frame leaks. Corbel deterioration and infiltration. Barrel infiltration.

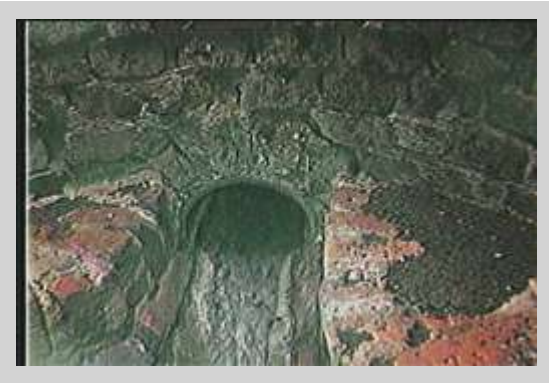
8 in. Circular Gravity Sewer Pipe Out @ 12 O'Clock

Barrel deterioration and infiltration. Channel deterioration.

Infiltration: **Evidence** Pipe Seal Cond: **Cracked**

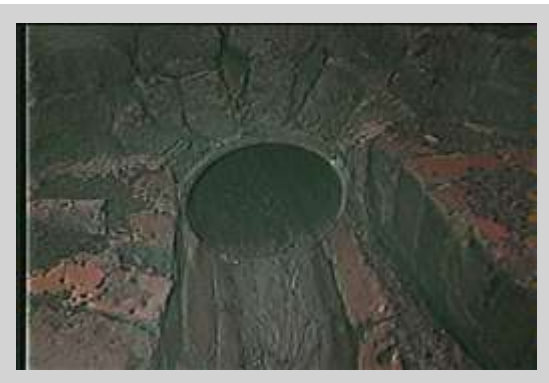
8 in. Circular Gravity Sewer Pipe In @ 5 O'Clock

Barrel deterioration and infiltration. Bench and Channel deterioration.

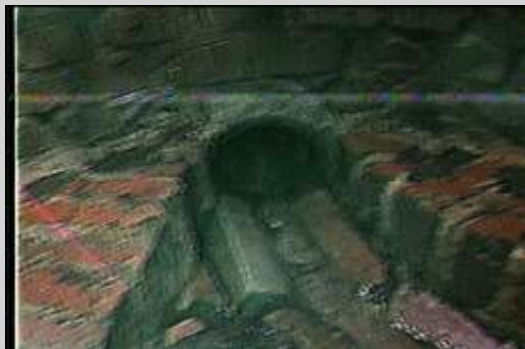
6 in. Circular Gravity Sewer

Barrel deterioration and infiltration. Channel deterioration.

Infiltration: **Evidence**
